APPENDIX B

ADMINISTRATIVE AND ANALYTICAL DOCUMENTS

Name of Action or Project: Riverview Lofts		
Project Location (describe, and attach a general location map): Southwest corner, East Main Street (#221) and McDermott Avenue (#31), Riverhead (SCTM#: 0600-129-01-21 & 22)		
Brief Description of Proposed Action (include purpose or need): see attached		
Name of Applicant/Sponsor: Georgica Green Ventures, LLC, Matthew Ardito		Telephone: (516) 390-9384
		E-Mail: matthewardito@georgicagreen.com
Address: 50 Jericho Quadrangle, Suite 200		
City/PO: Jericho	State: NY	Zip Code: 11753
Project Contact (if not same as sponsor; give name and title/role): (same)		Telephone:
		E-Mail:
Address:		
City/PO:	State:	Zip Code:
Property Owner (if not same as sponsor): (same)		Telephone:
		E-Mail:
Address:		
City/PO:	State:	Zip Code:

PROJECT DESCRIPTION

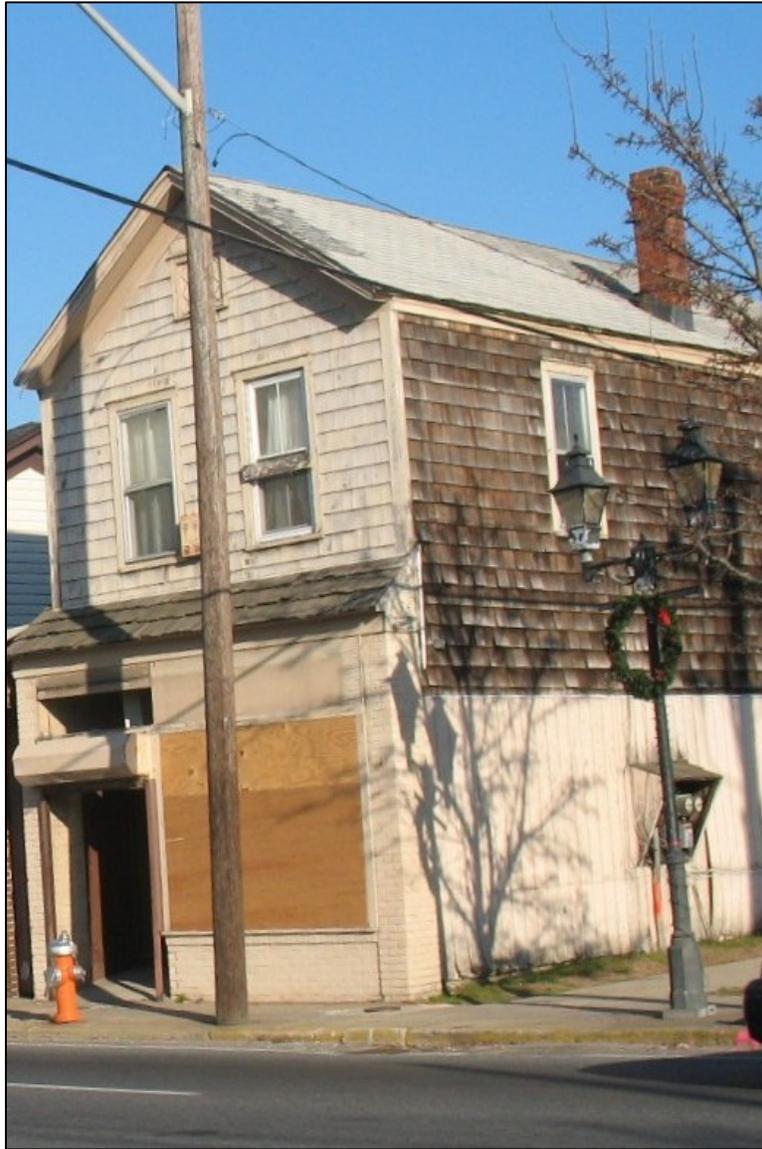
Exhibit E-1: A deteriorated building (Tax map number 0600-128-6-86.3) located on the east side of Peconic Avenue, north of the parking lot access road.

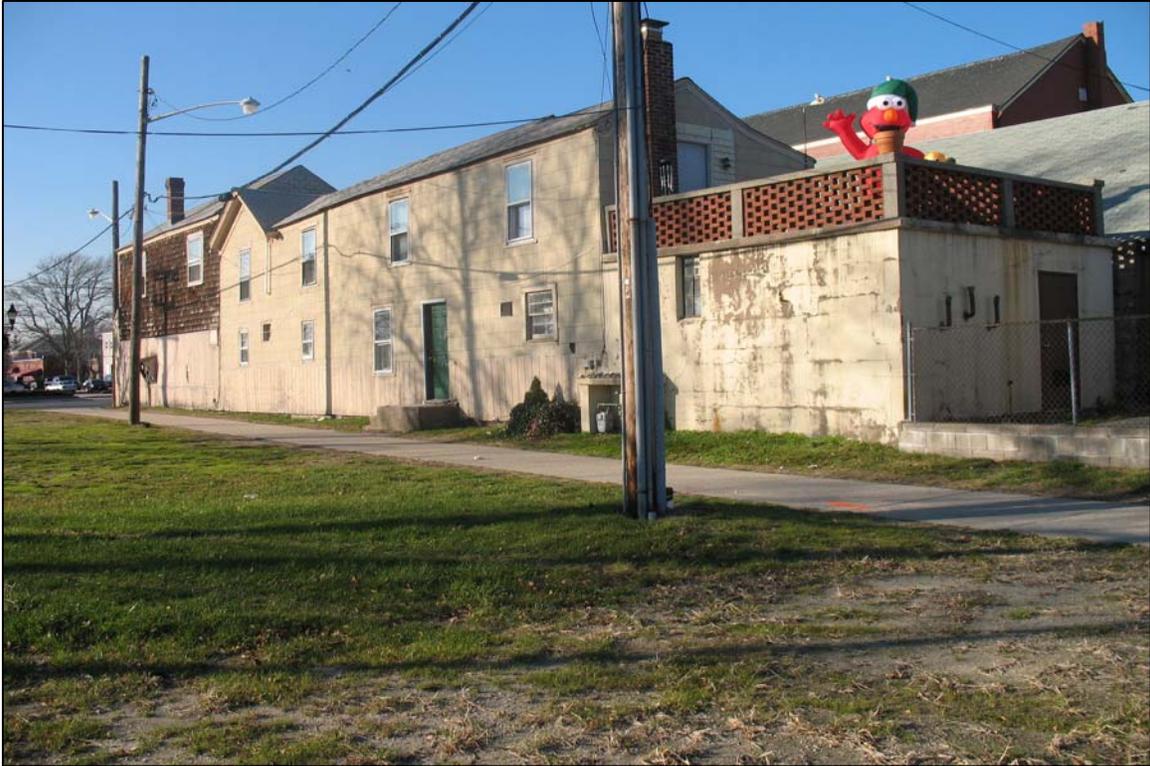
Exhibit E-2: Side view of Exhibit E-1 (Tax map number 0600-128-6-86.3) located on the east side of Peconic Avenue, north of the parking lot access road.

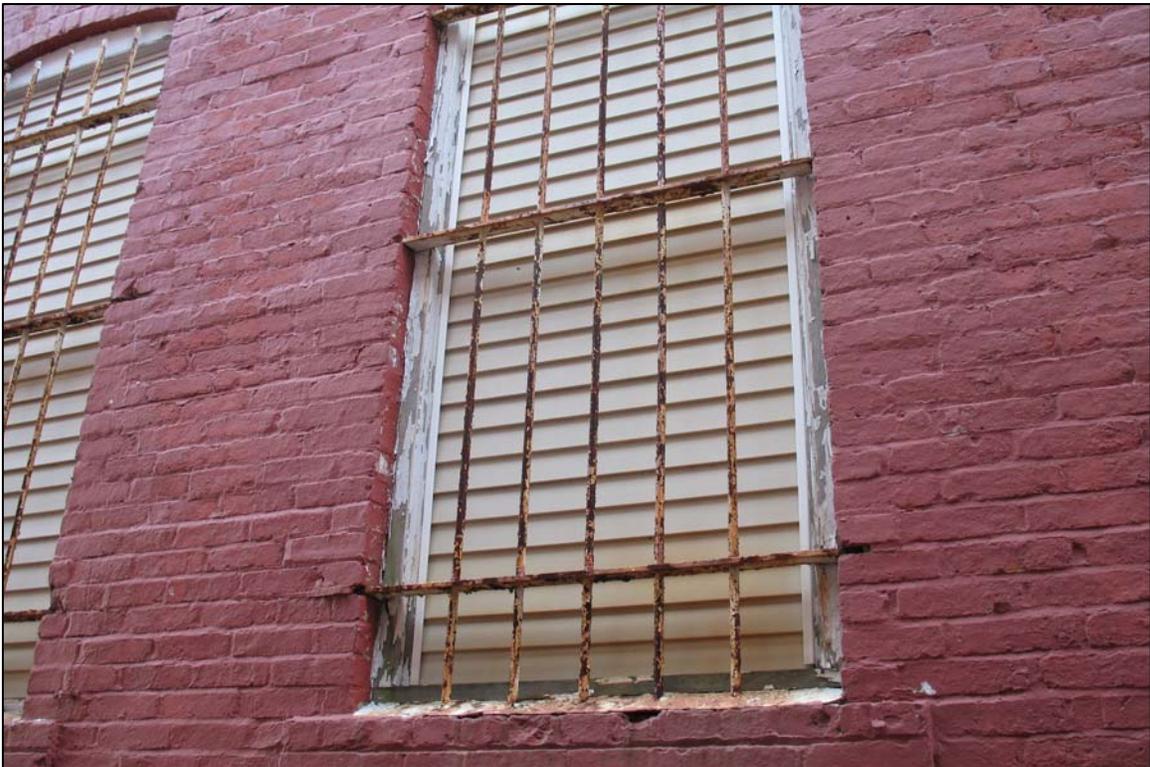
Exhibit E-3: Side view of a deteriorated building (Tax map number 0600-128-6-73.1) located on the south side of East Main Street, east of the major access road into the parking lot.

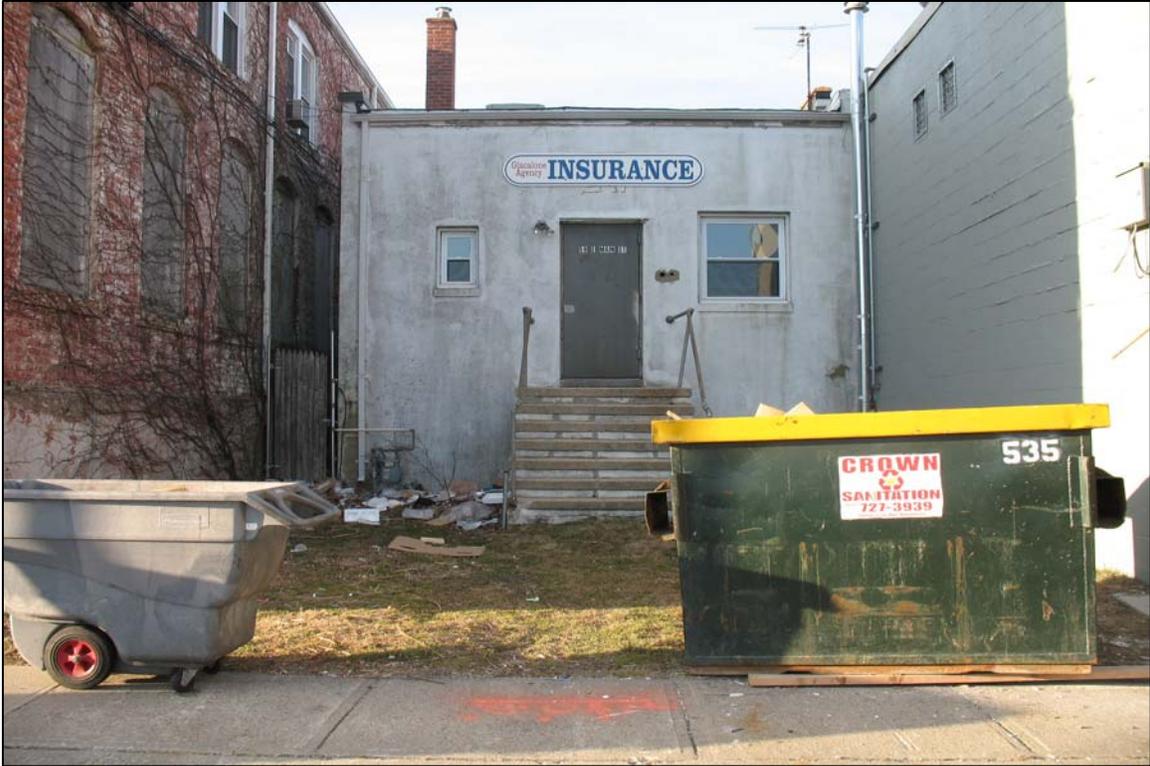
Exhibit E-4: Rear view of a deteriorated building (Tax map number 0600-128-6-75) located on the south side of East Main Street, north of the parking lot within the southwest portion of the EMSURA.

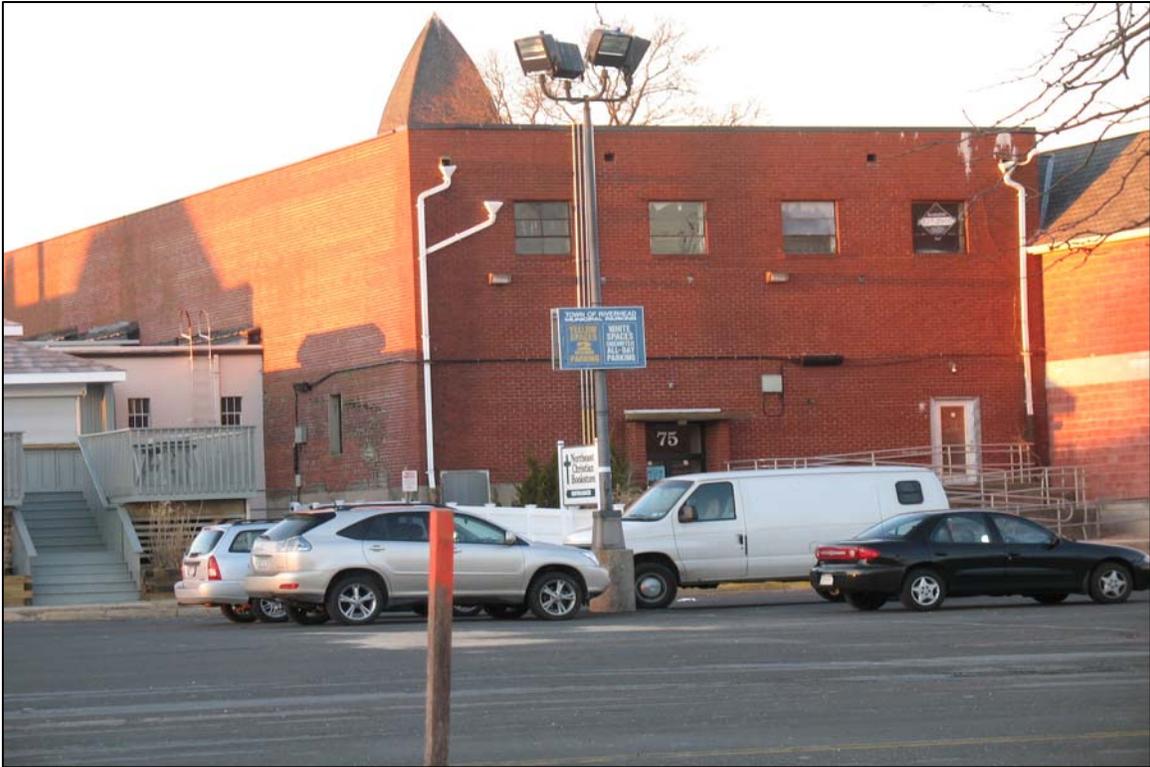
Exhibit E-5: Rear view of a deteriorated building (Tax map number 0600-128-6-77) located on the south side of East Main Street, north of the parking lot within the southwest portion of the EMSURA.

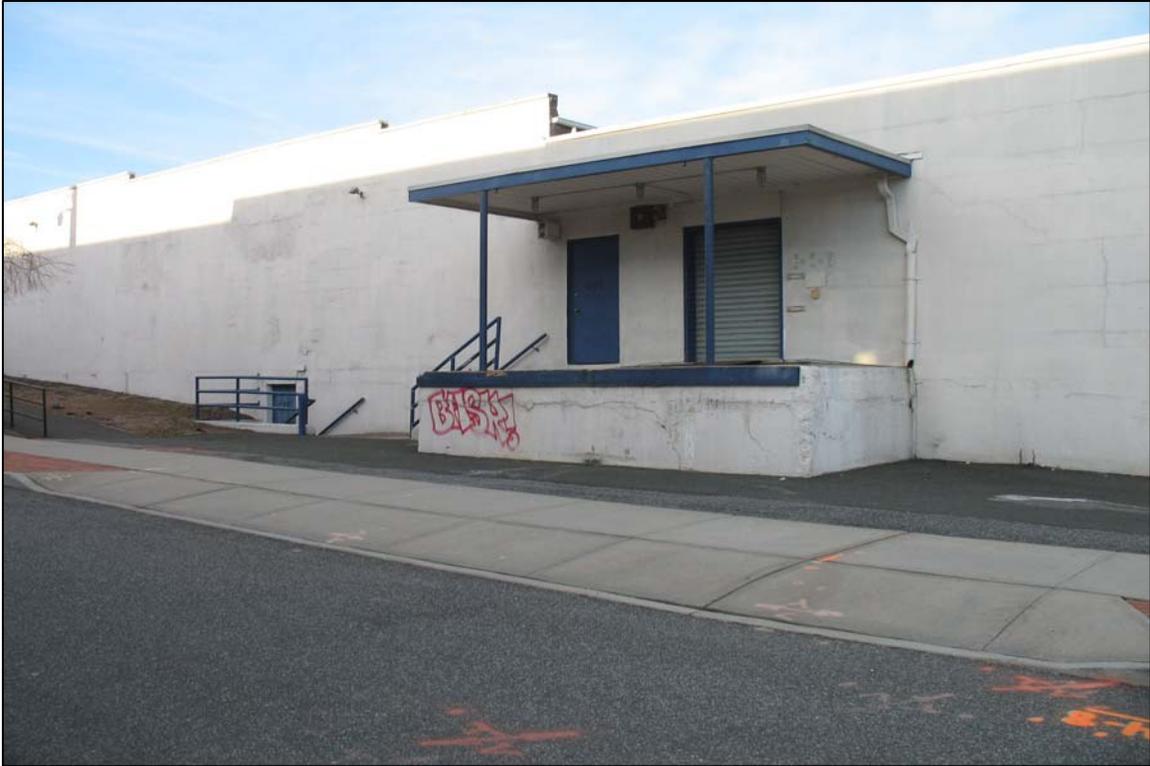
Exhibit E-6: Side view of a deteriorated building (Tax map number 0600-129-1-10) located east of the parking lot access road within the southeast portion of the EMSURA.

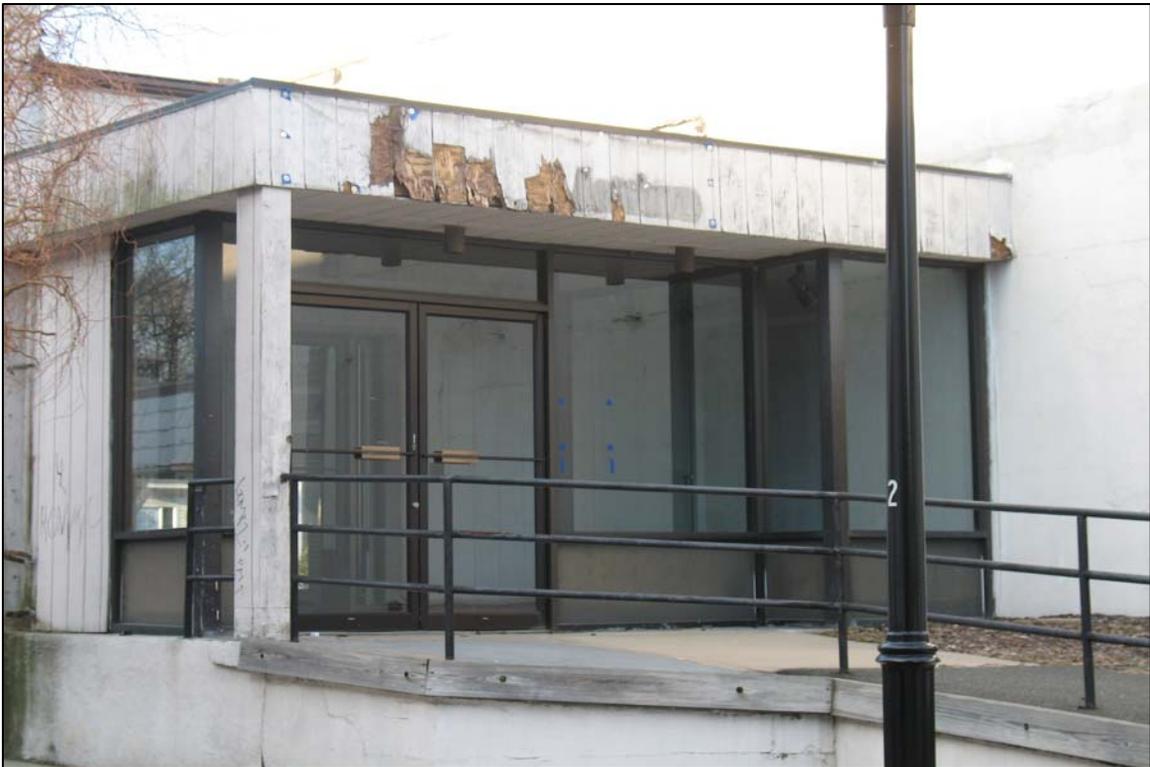
Exhibit E-7: Side and rear view of Exhibit E-6 (Tax map number 0600-129-1-10) located east of the parking lot access road within the southeast portion of the EMSURA.

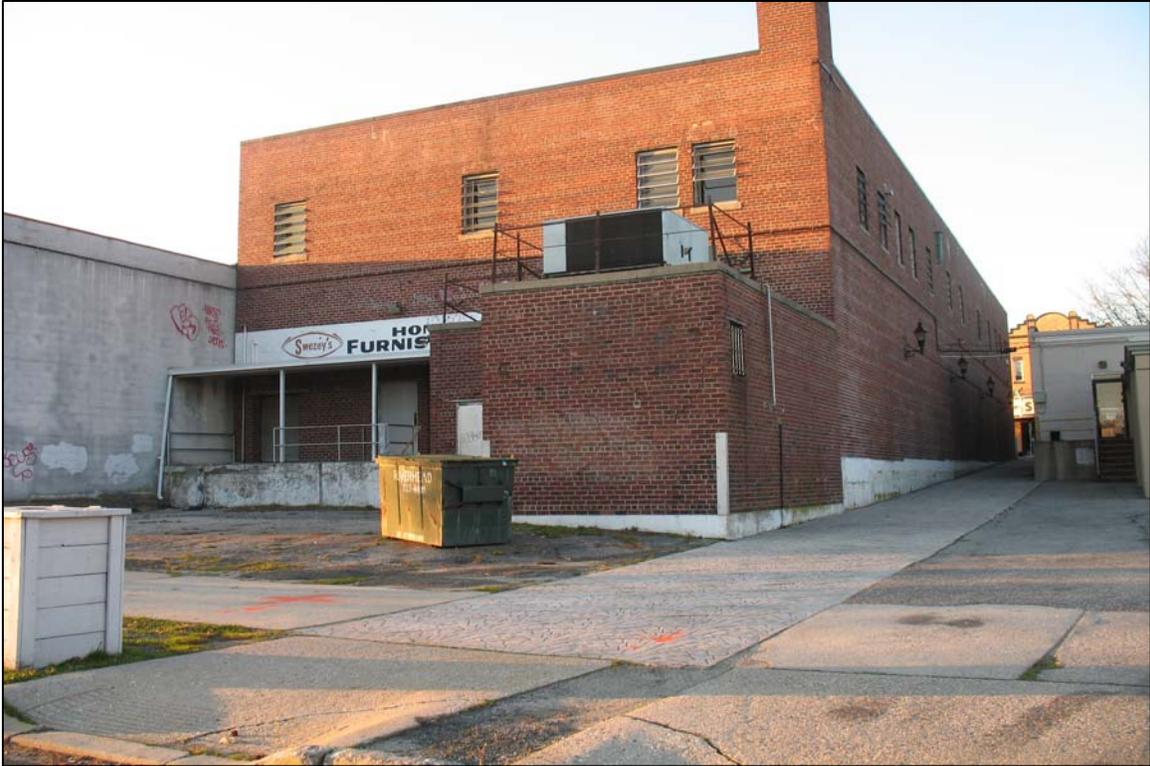
Exhibit E-8: Rear view of deteriorated buildings (Tax map number 0600-129-1-12 and part of 129-1-11) located on the south side of East Main Street, west of McDermott Avenue and north of the parking lot within the southeast portion of the EMSURA.

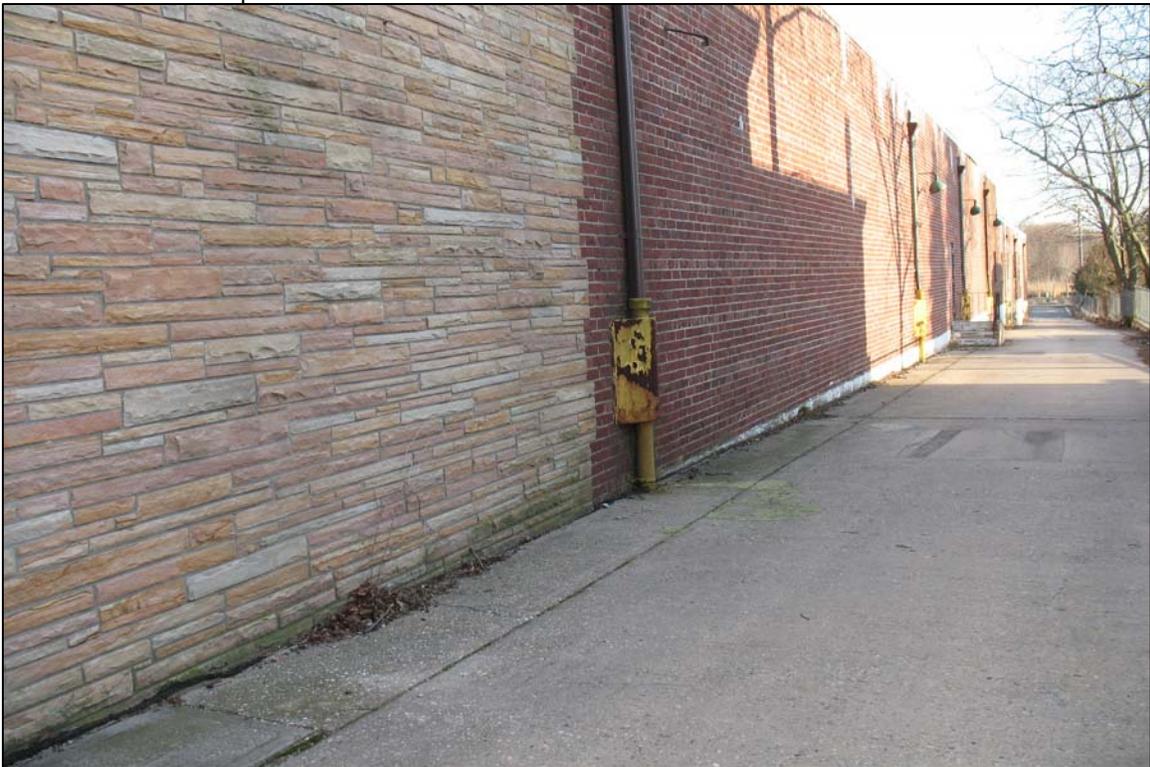
Exhibit E-9: Side view of a deteriorated building (Tax map number 0600-129-1-17) on the south side of East Main Street, just east of the East End Arts Council.

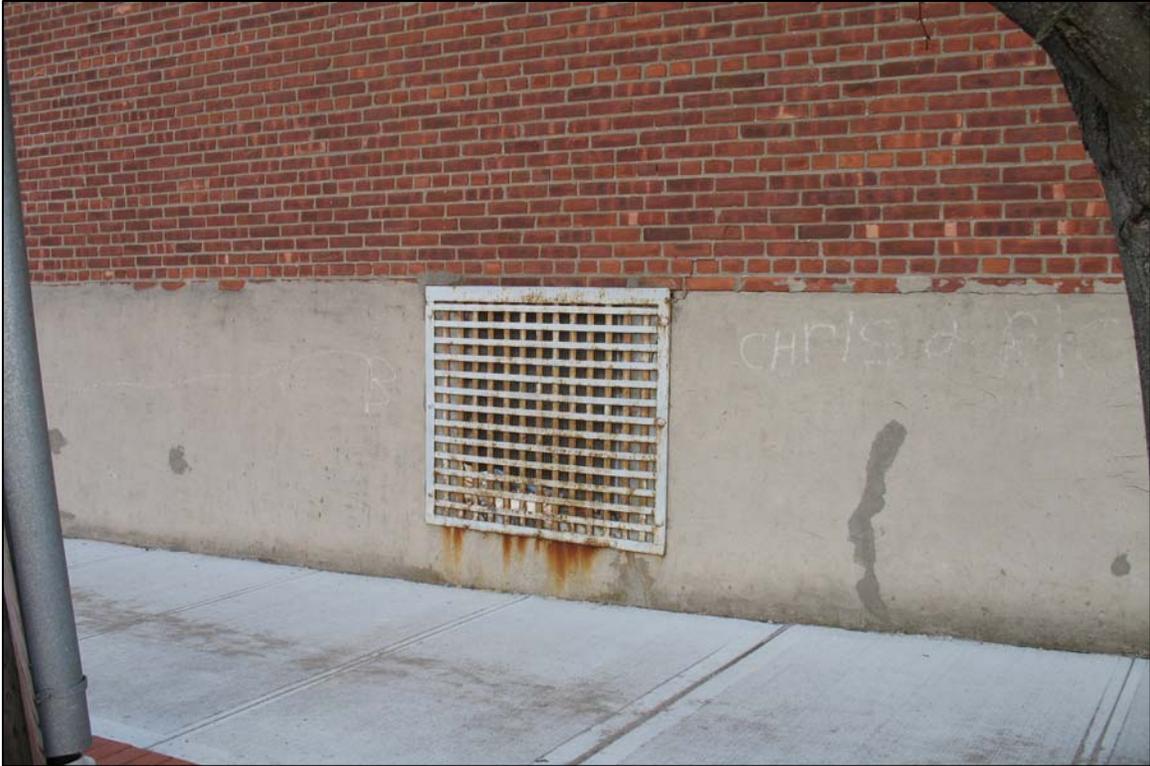
Exhibit E-10: Side view of a deteriorated building (Tax map number 0600-129-1-21) located on the south side of East Main Street, just west of McDermott Avenue.

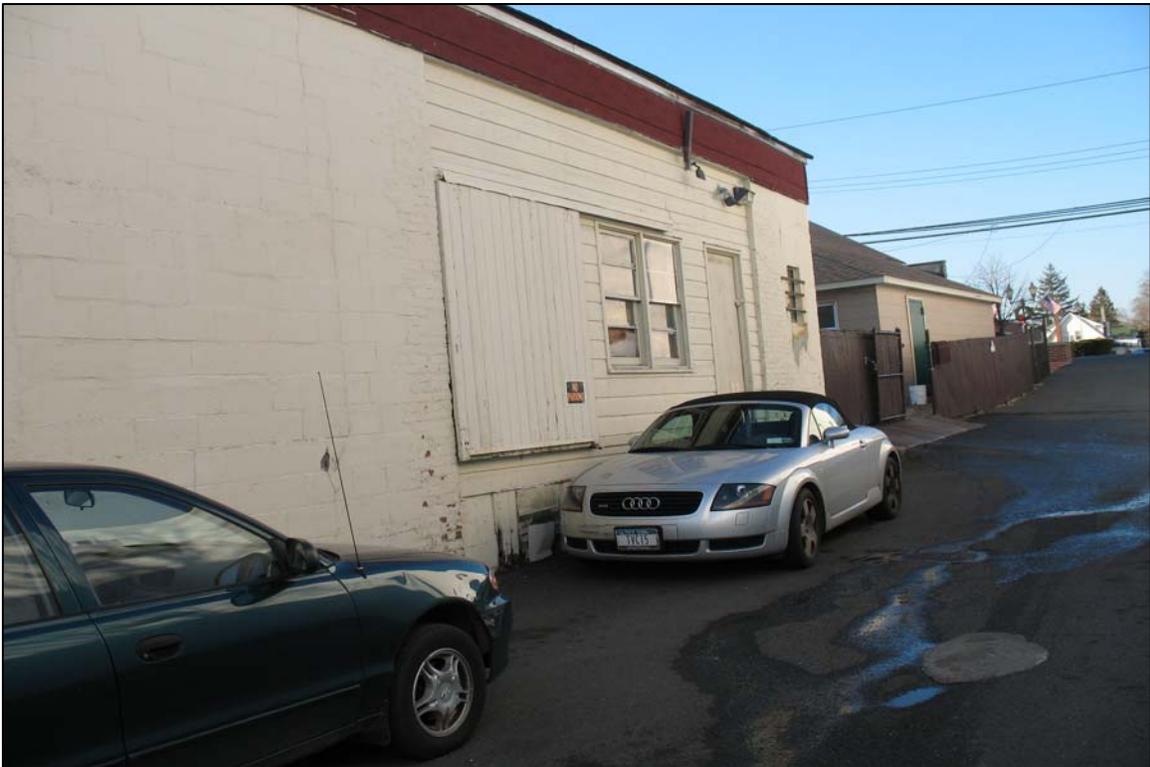
Exhibit E-11: Side view of a deteriorated building (Tax map number 0600-129-4-13.1) located west of McDermott Avenue behind structures fronting on East Main Street.

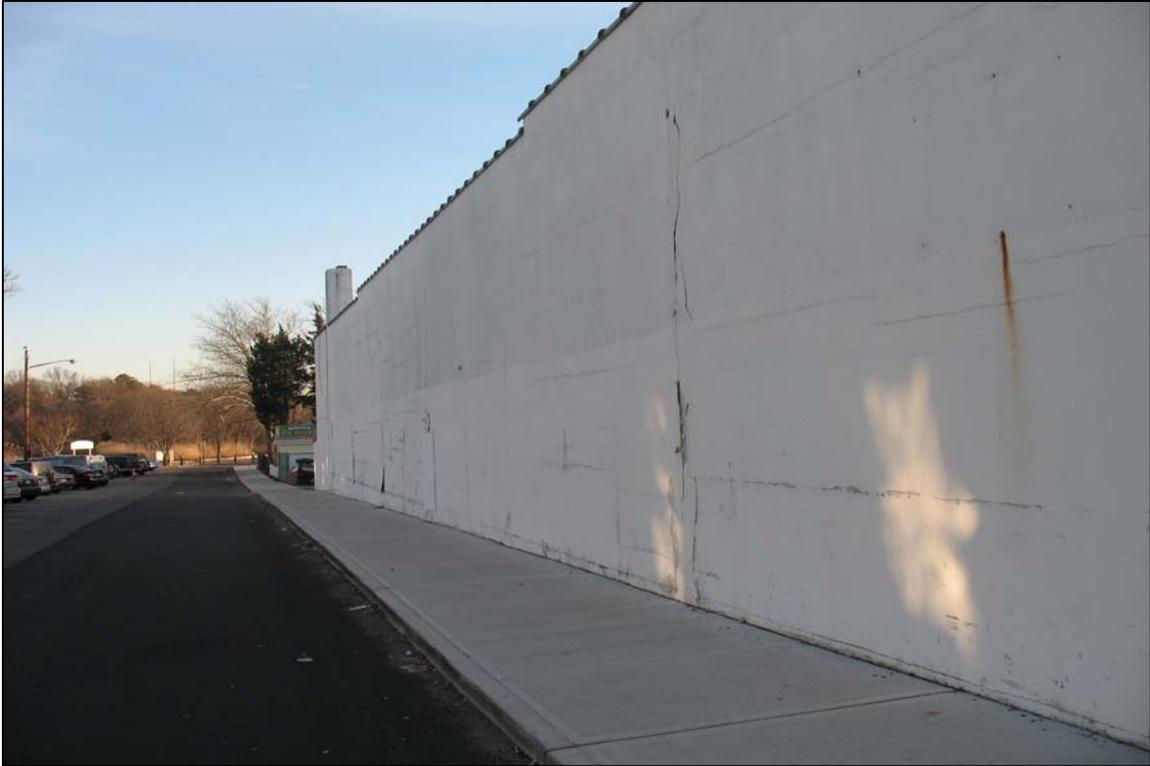
Exhibit E-12: Side view of a deteriorated building (Tax map number 0600-129-4-13.2) located west of the access road/parking lot on the south side of East Main Street, west of McDermott Avenue.

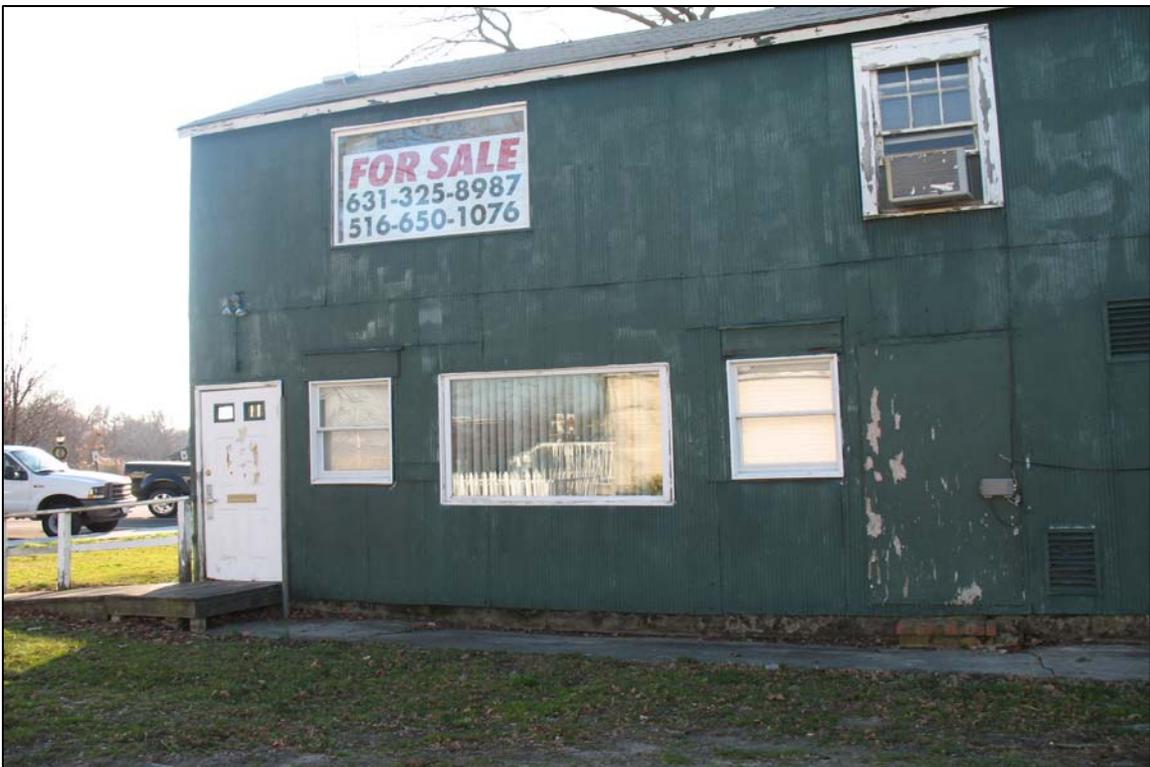
Exhibit E-13: Side view of a deteriorated building (Tax map number 0600-129-4-10.6) located behind the Thrift Store on the south side of East Main Street within the southeast portion of the EMSURA.

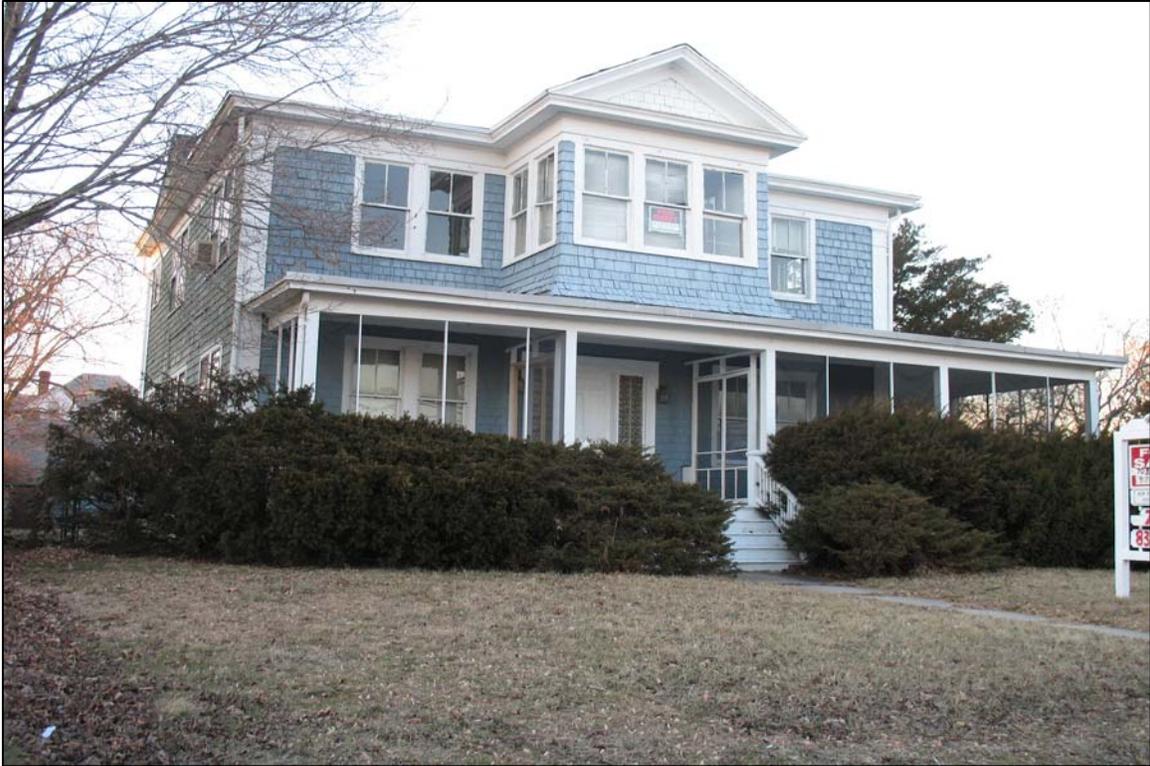
Exhibit E-14: A deteriorated building (Tax map number 0600-129-3-13) located on the north side of East Main Street, just west of Ostrander Avenue.

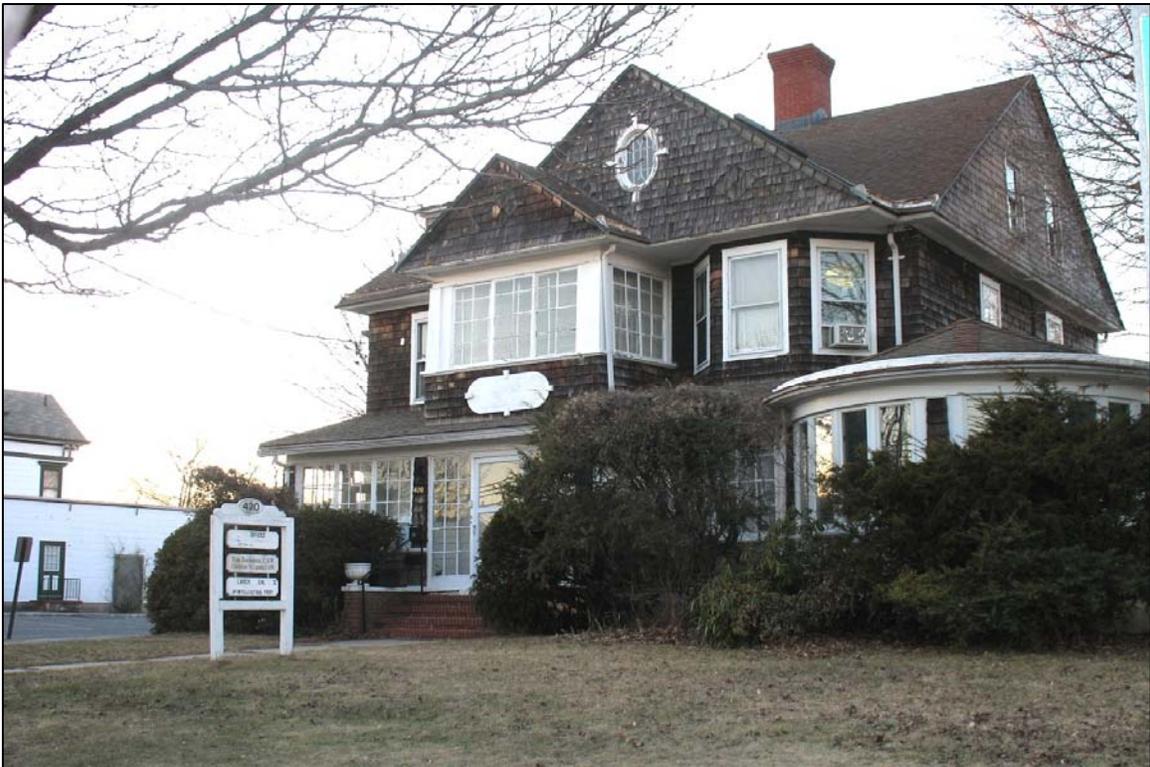
Exhibit E-15: A deteriorated building (Tax map number 0600-129-3-12) located on the north side of East Main Street, just west of Exhibit E-14.

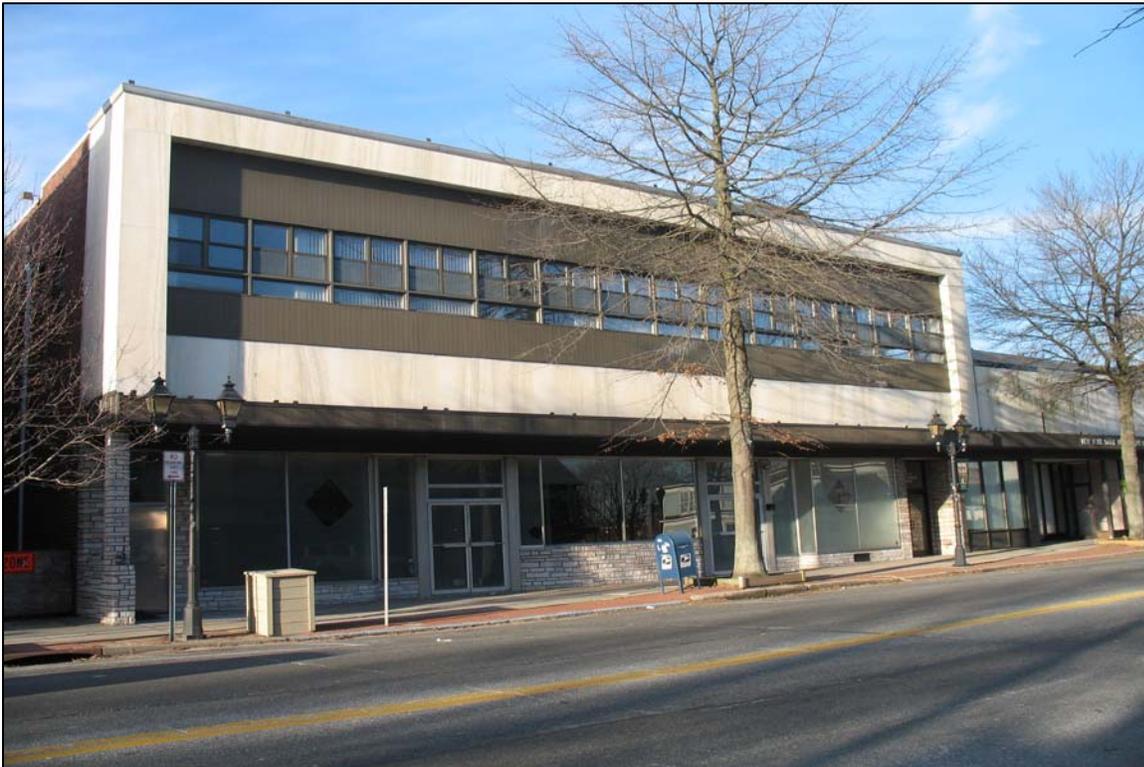
Exhibit E-16: A deteriorated building (Tax map number 0600-129-1-8.2) located on the north side of East Main Street, west of East Avenue.

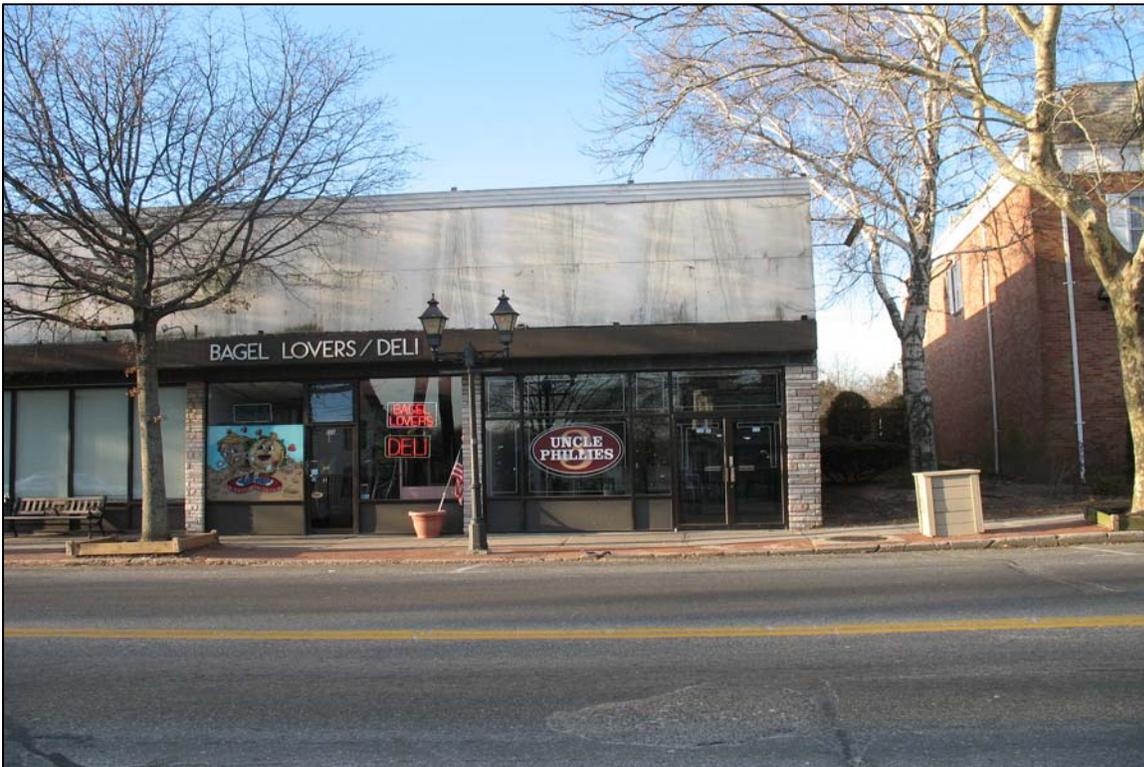
Exhibit E-17: A view of the eastern portion of Exhibit E-17 (Tax map number 0600-129-1-8.2) located on the north side of East Main Street, west of East Avenue.

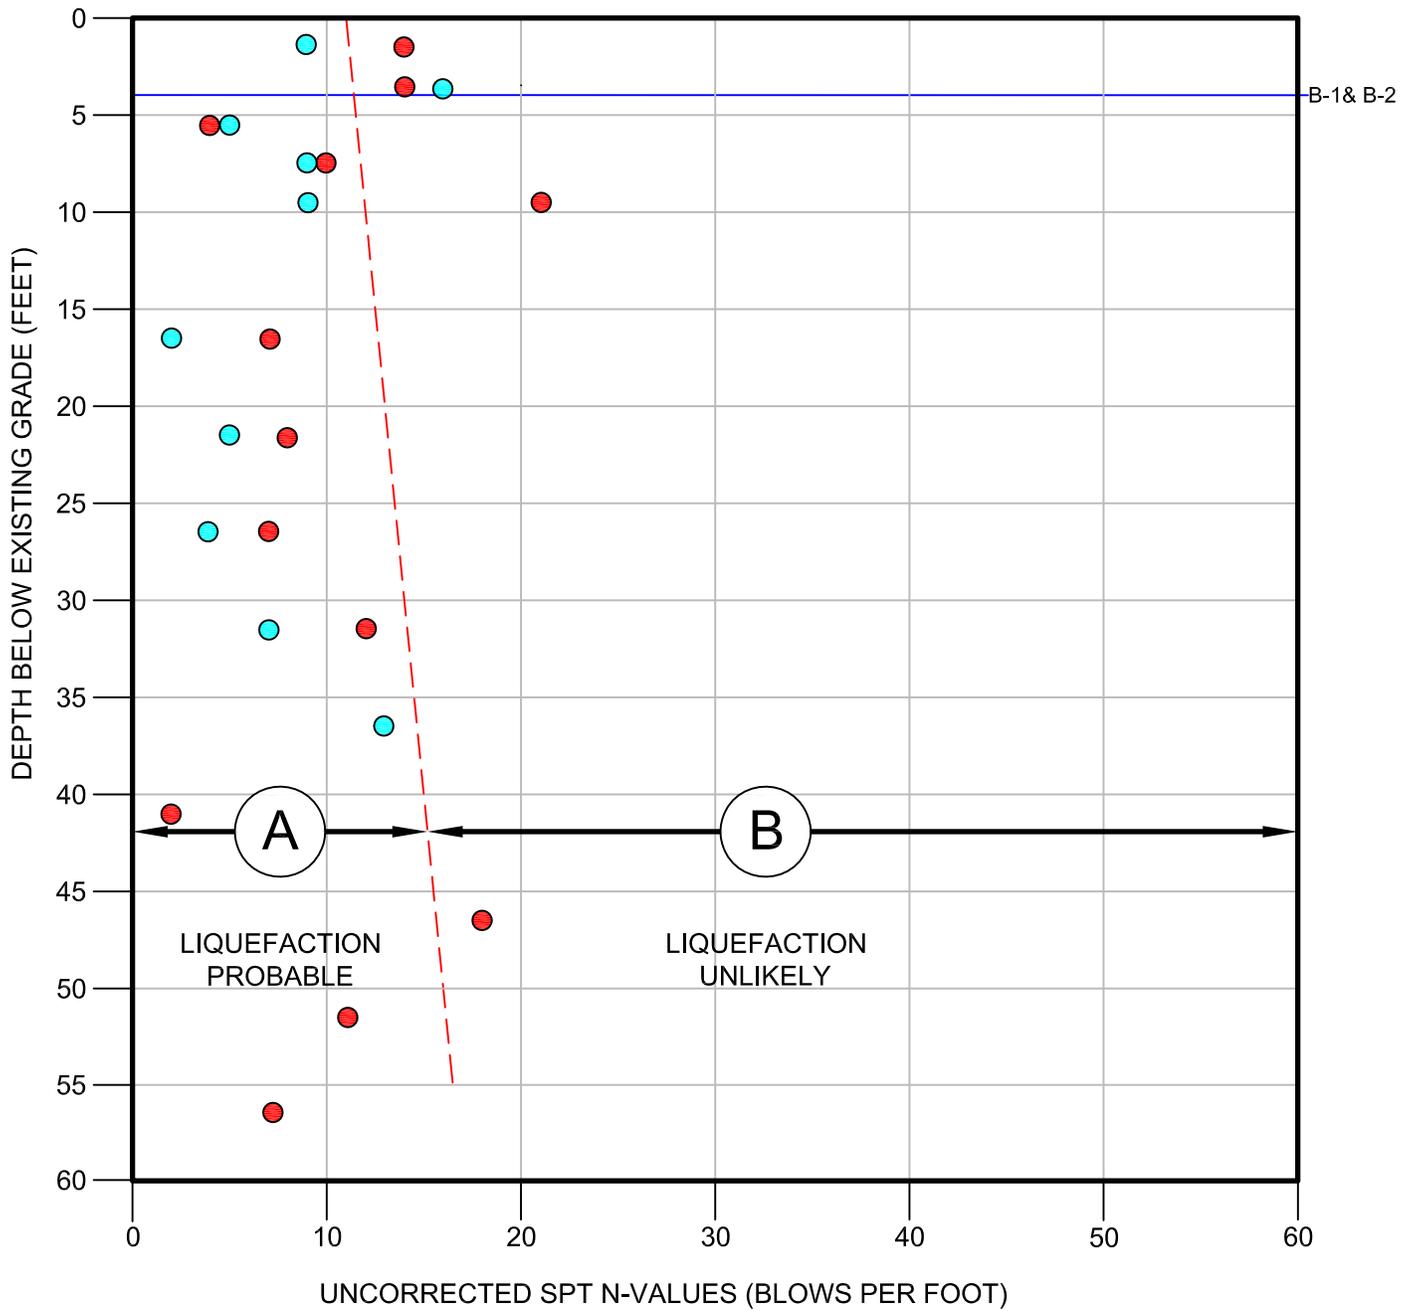
THIS FIGURE IS BASED ON THE LIQUEFACTION CRITERIA FROM THE SEISMIC PROVISIONS OF THE 2014 NYC BUILDING CODE

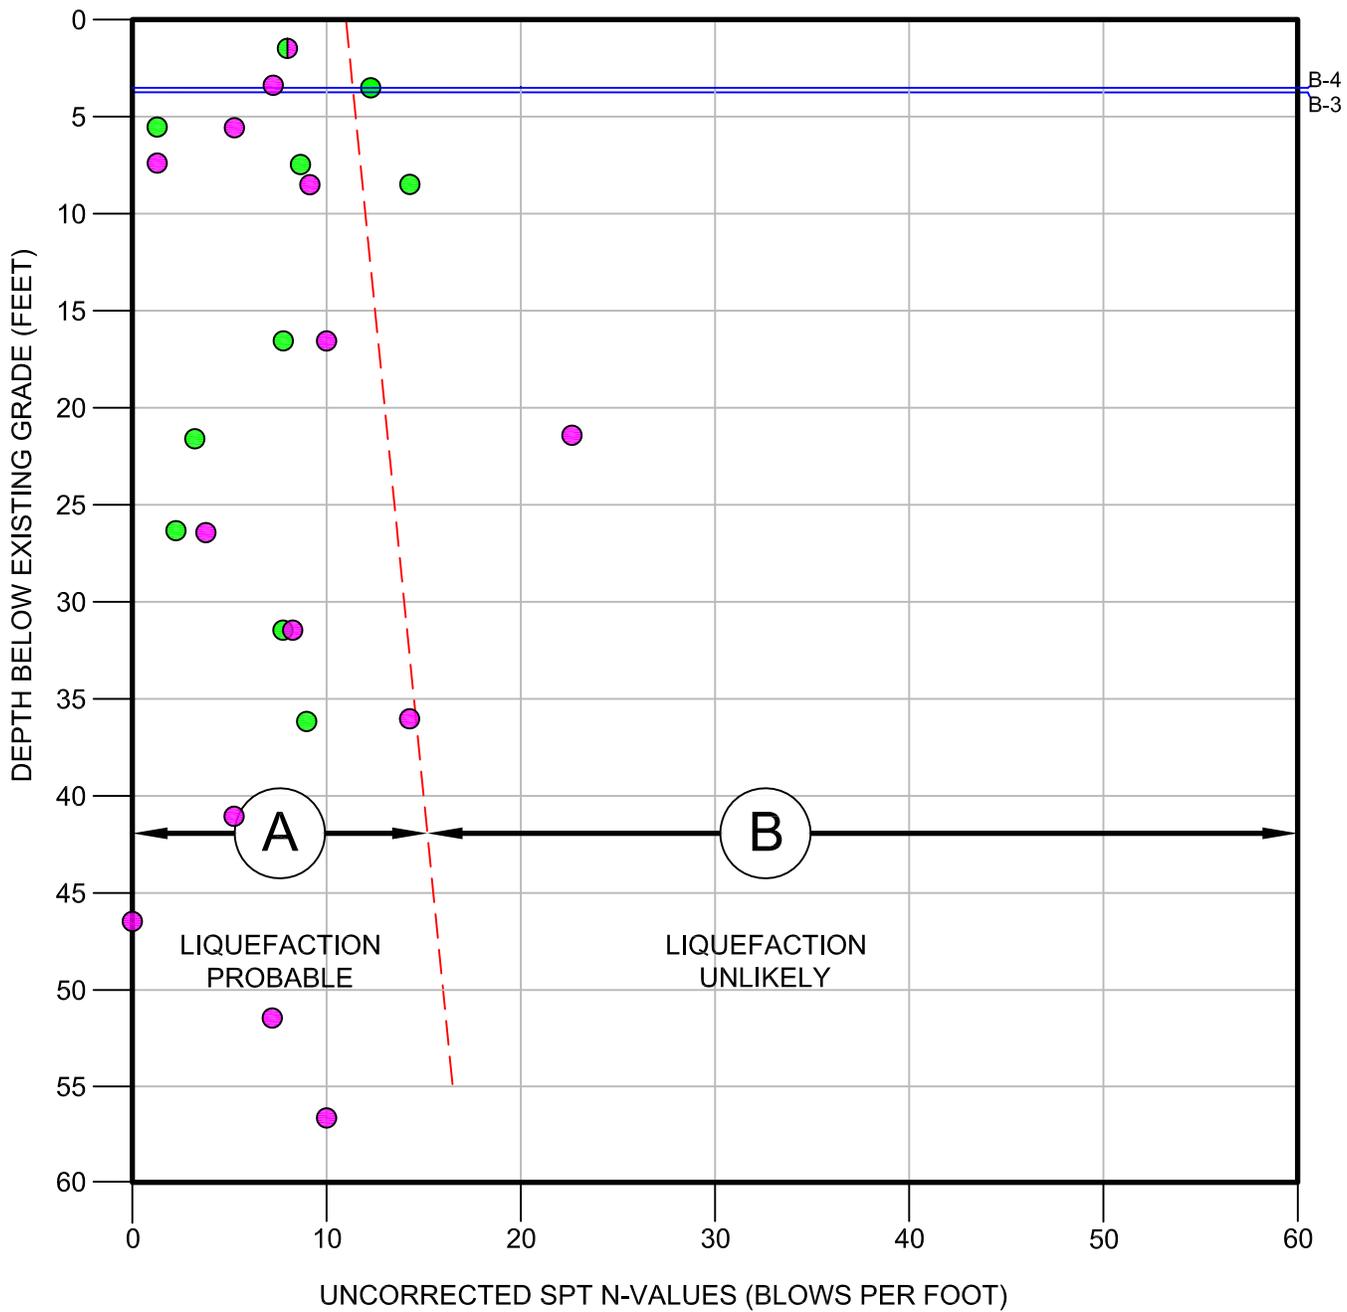
THIS FIGURE IS BASED ON THE LIQUEFACTION CRITERIA FROM THE SEISMIC PROVISIONS OF THE 2014 NYC BUILDING CODE

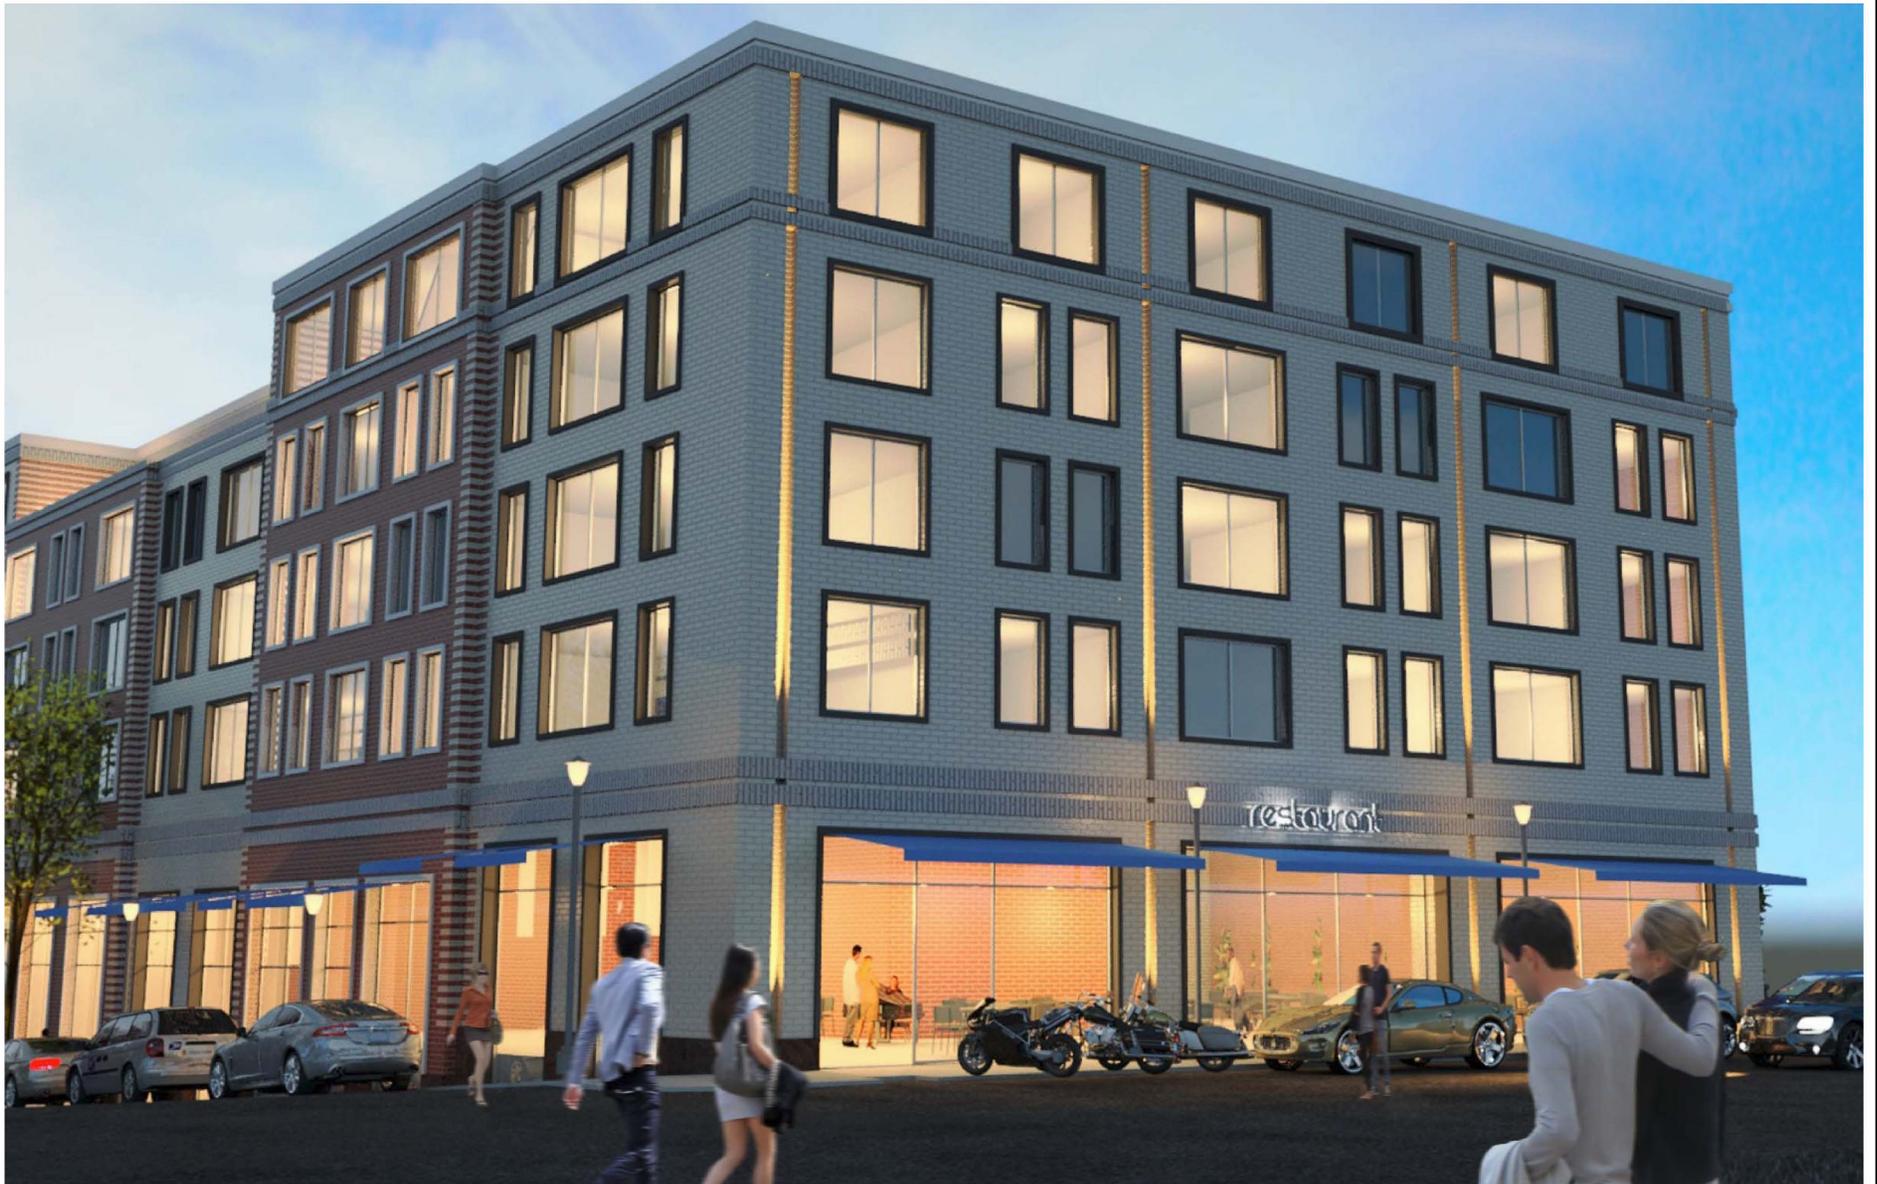
1. Simulated view of northeastern corner of proposed mixed-use structure, toward southwest across intersection of McDermott Ave and East Main Street.
