APPENDIX B

ADMINISTRATIVE AND ANALYTICAL DOCUMENTS

Name of Action or Project: Riverview Lofts		
Project Location (describe, and attach a general location map): Southwest corner, East Main Street (#221) and McDermott Avenue (#31), Riverhead (SCTM#: 0600-129-01-21 & 22)		
Brief Description of Proposed Action (include purpose or need): see attached		
Name of Applicant/Sponsor: Georgica Green Ventures, LLC, Matthew Ardito		Telephone: (516) 390-9384
		E-Mail: matthewardito@georgicagreen.com
Address: 50 Jericho Quadrangle, Suite 200		
City/PO: Jericho	State: NY	Zip Code: 11753
Project Contact (if not same as sponsor; give name and title/role): (same)		Telephone:
		E-Mail:
Address:		
City/PO:	State:	Zip Code:
Property Owner (if not same as sponsor): (same)		Telephone:
		E-Mail:
Address:		
City/PO:	State:	Zip Code:

PROJECT DESCRIPTION

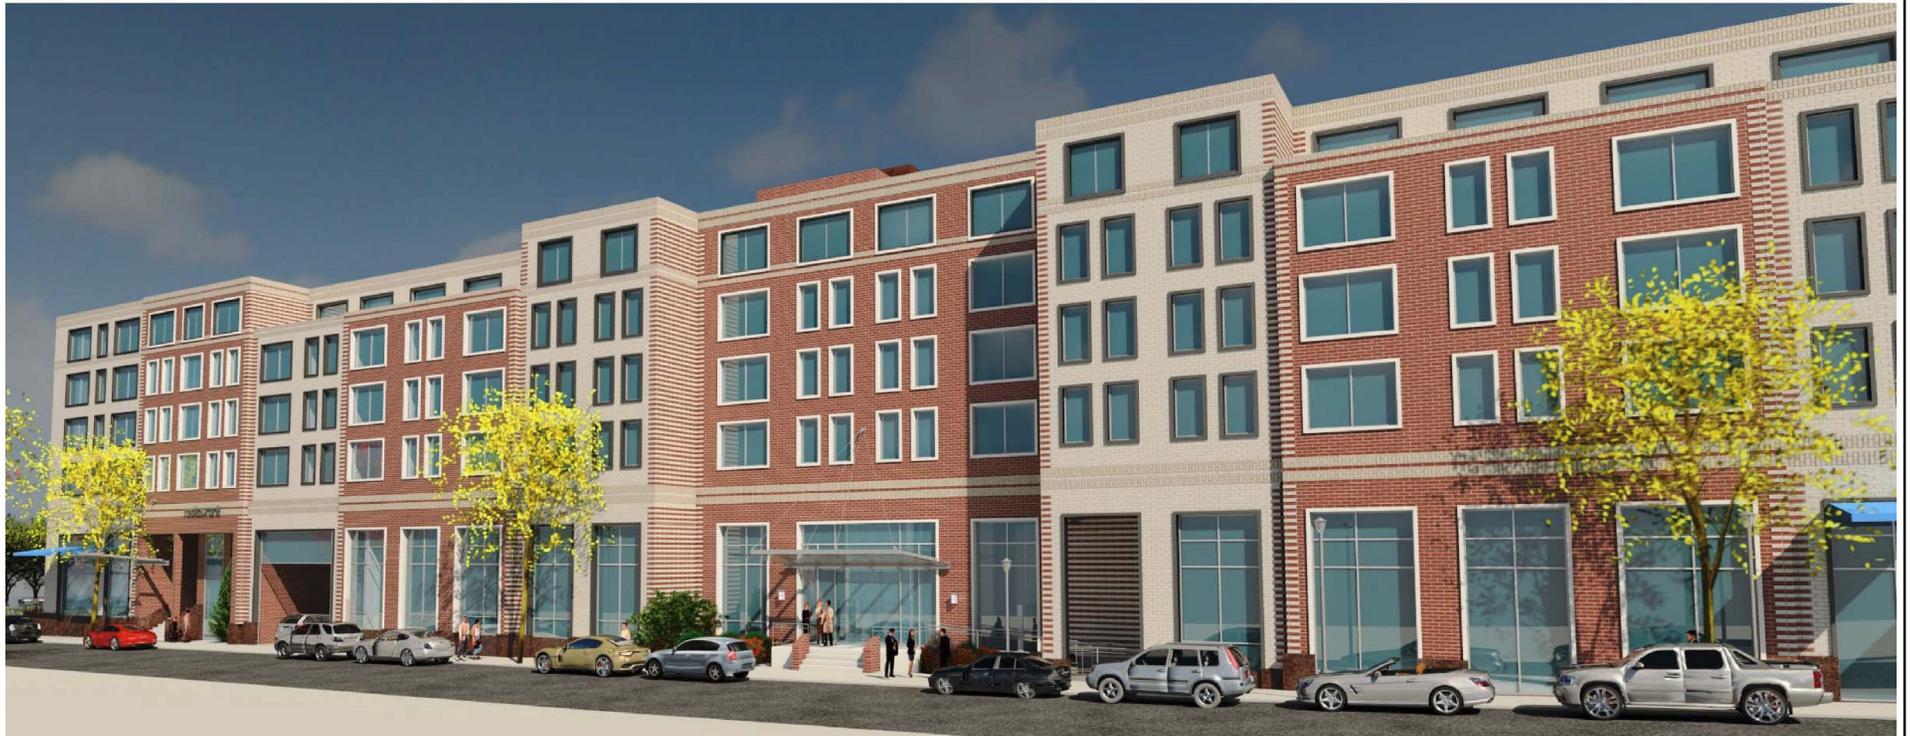
2. Simulated view of eastern side of proposed mixed-use structure, toward southwest across McDermott Ave.

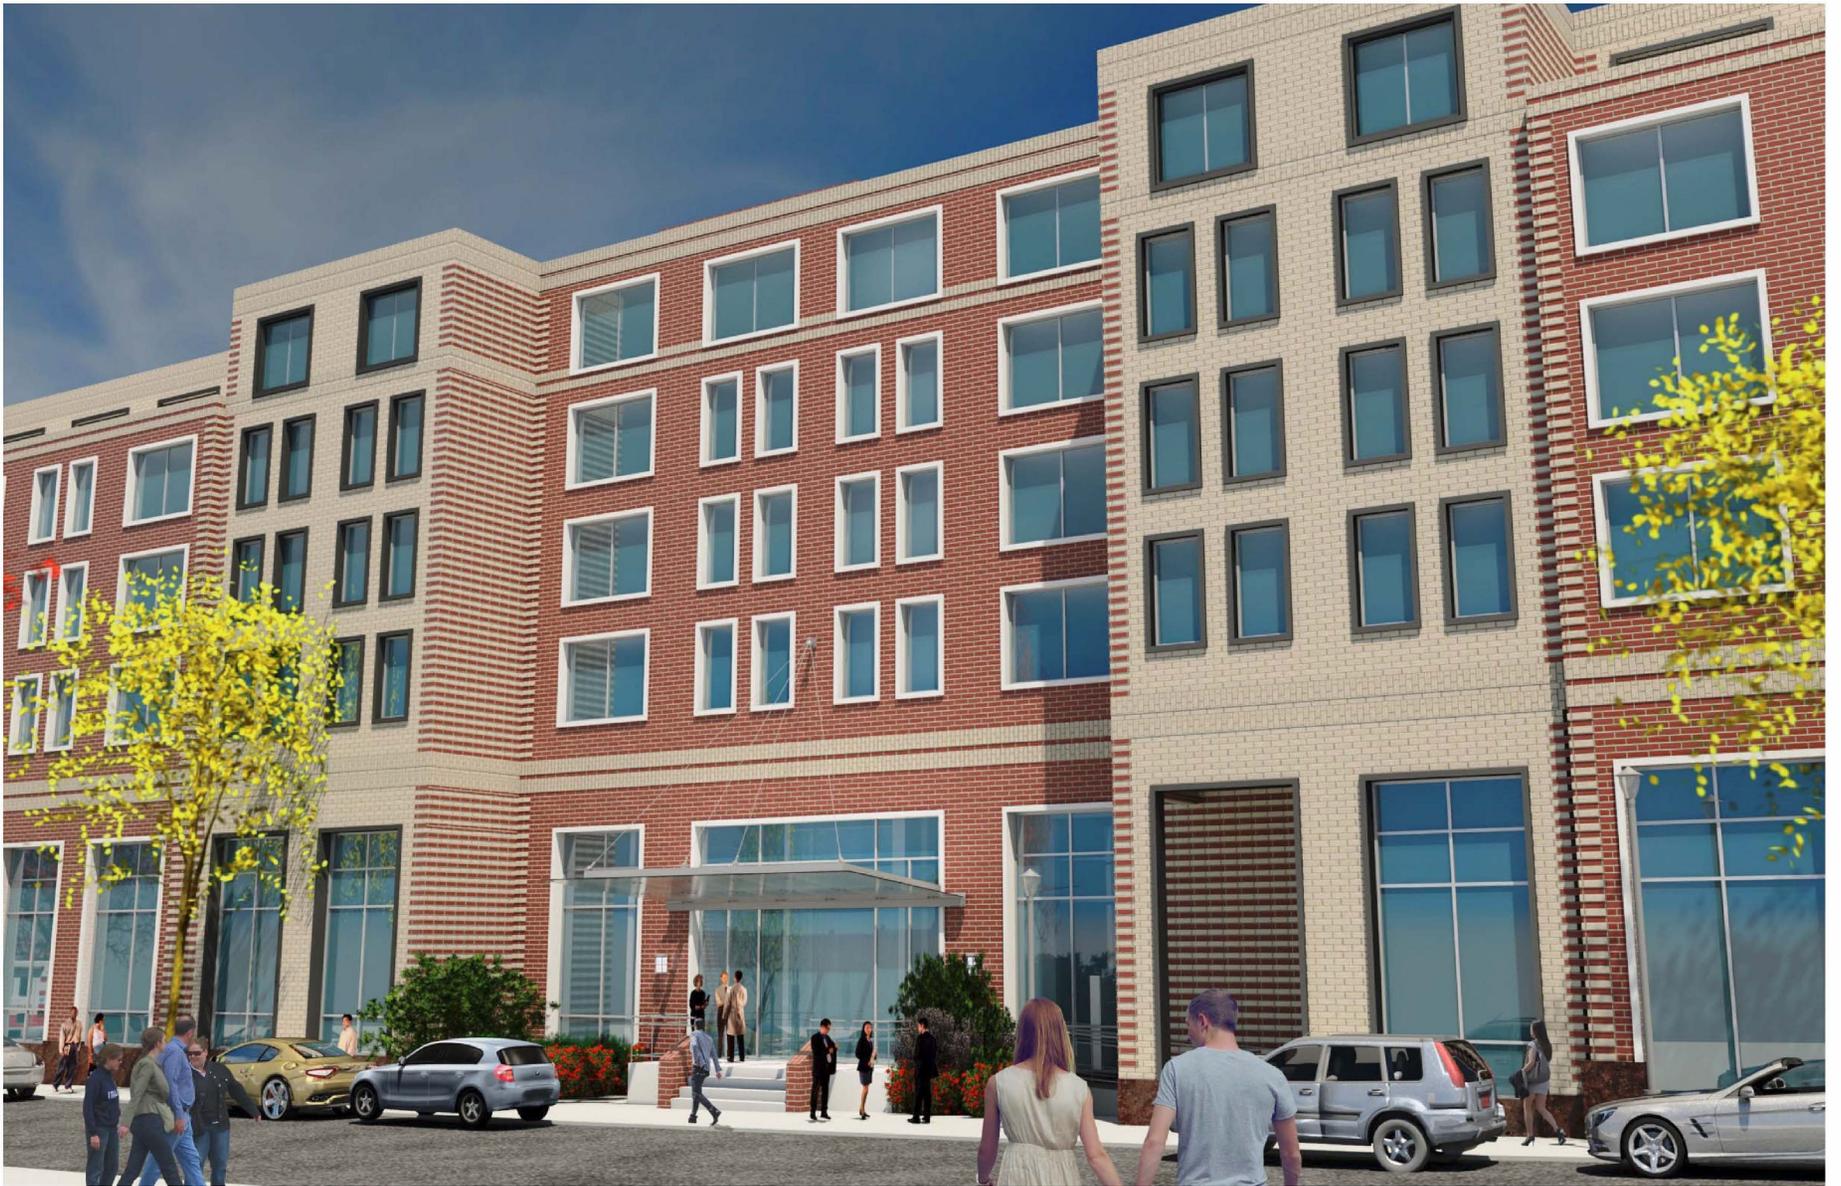
3. Simulated view of central portion of eastern side of proposed mixed-use structure, toward southwest across McDermott Ave.

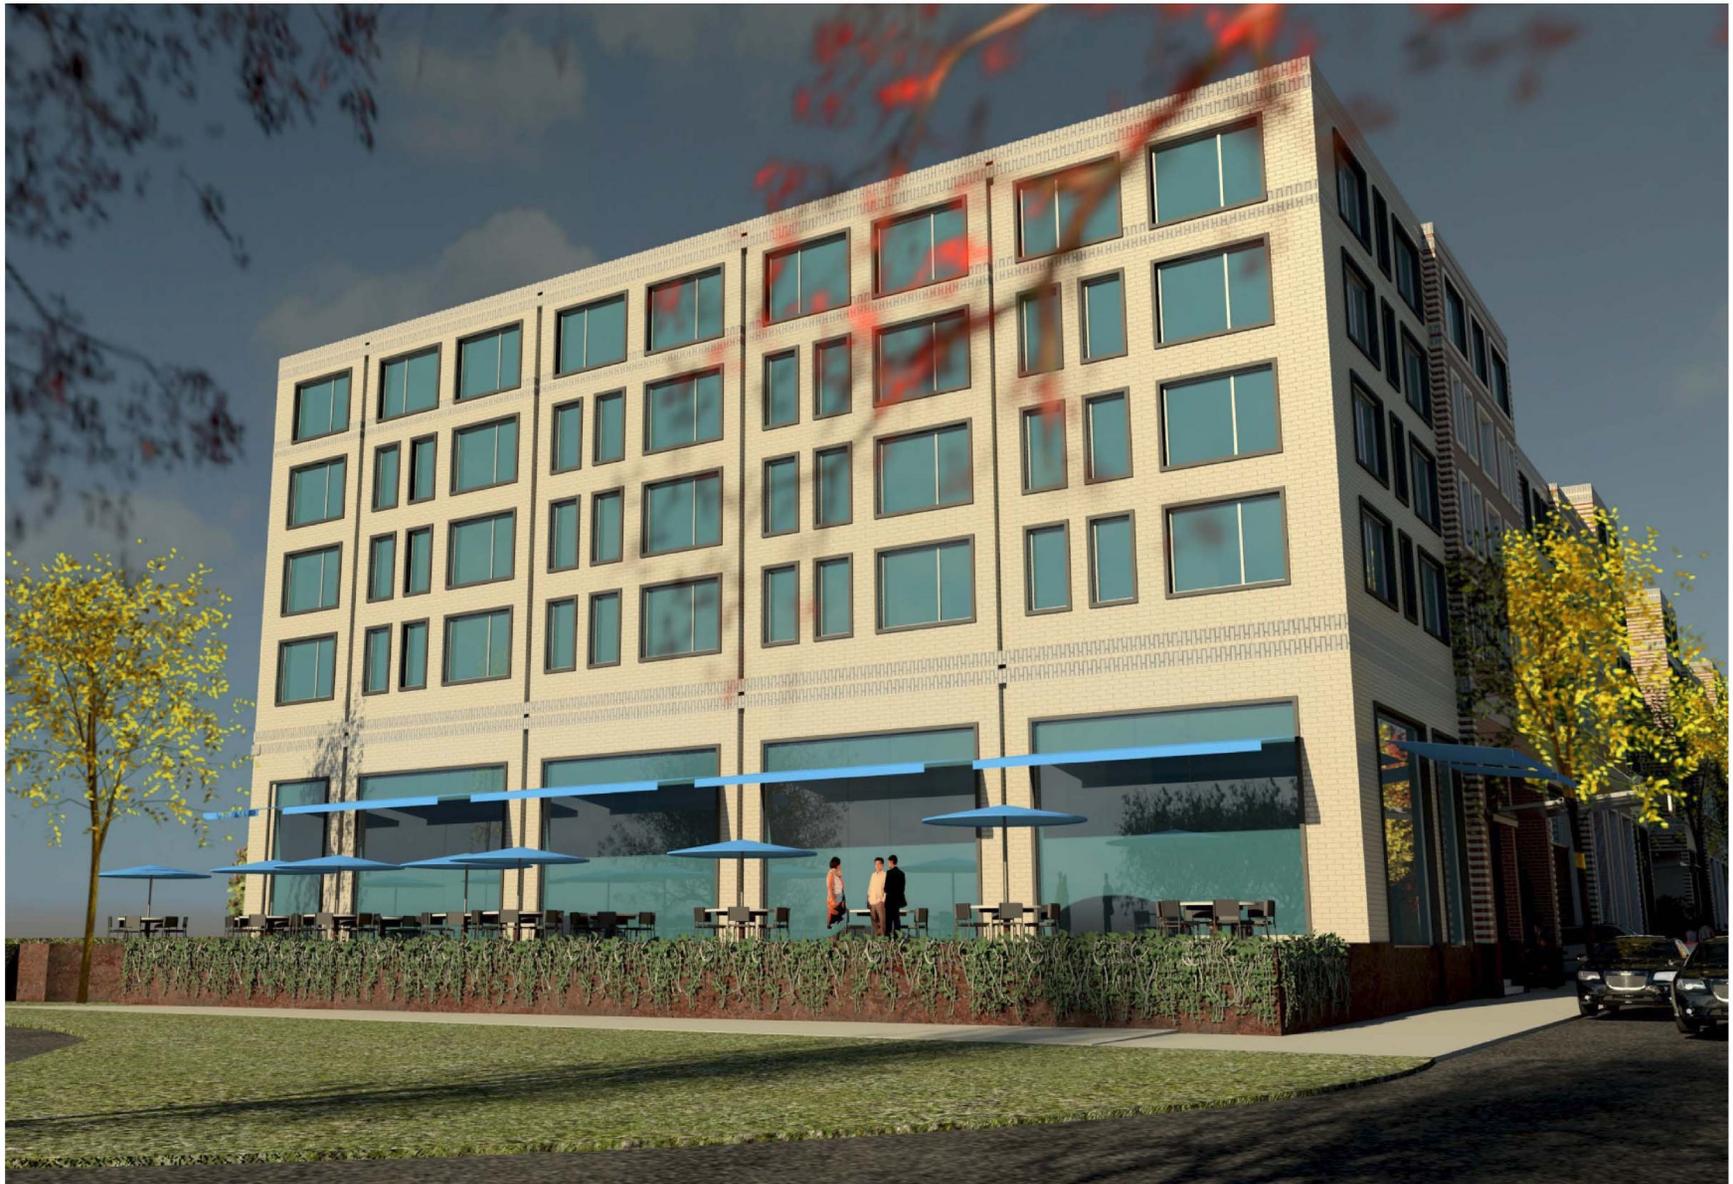
5. Simulated view of southern side of proposed mixed-use structure, toward northwest across McDermott Ave.

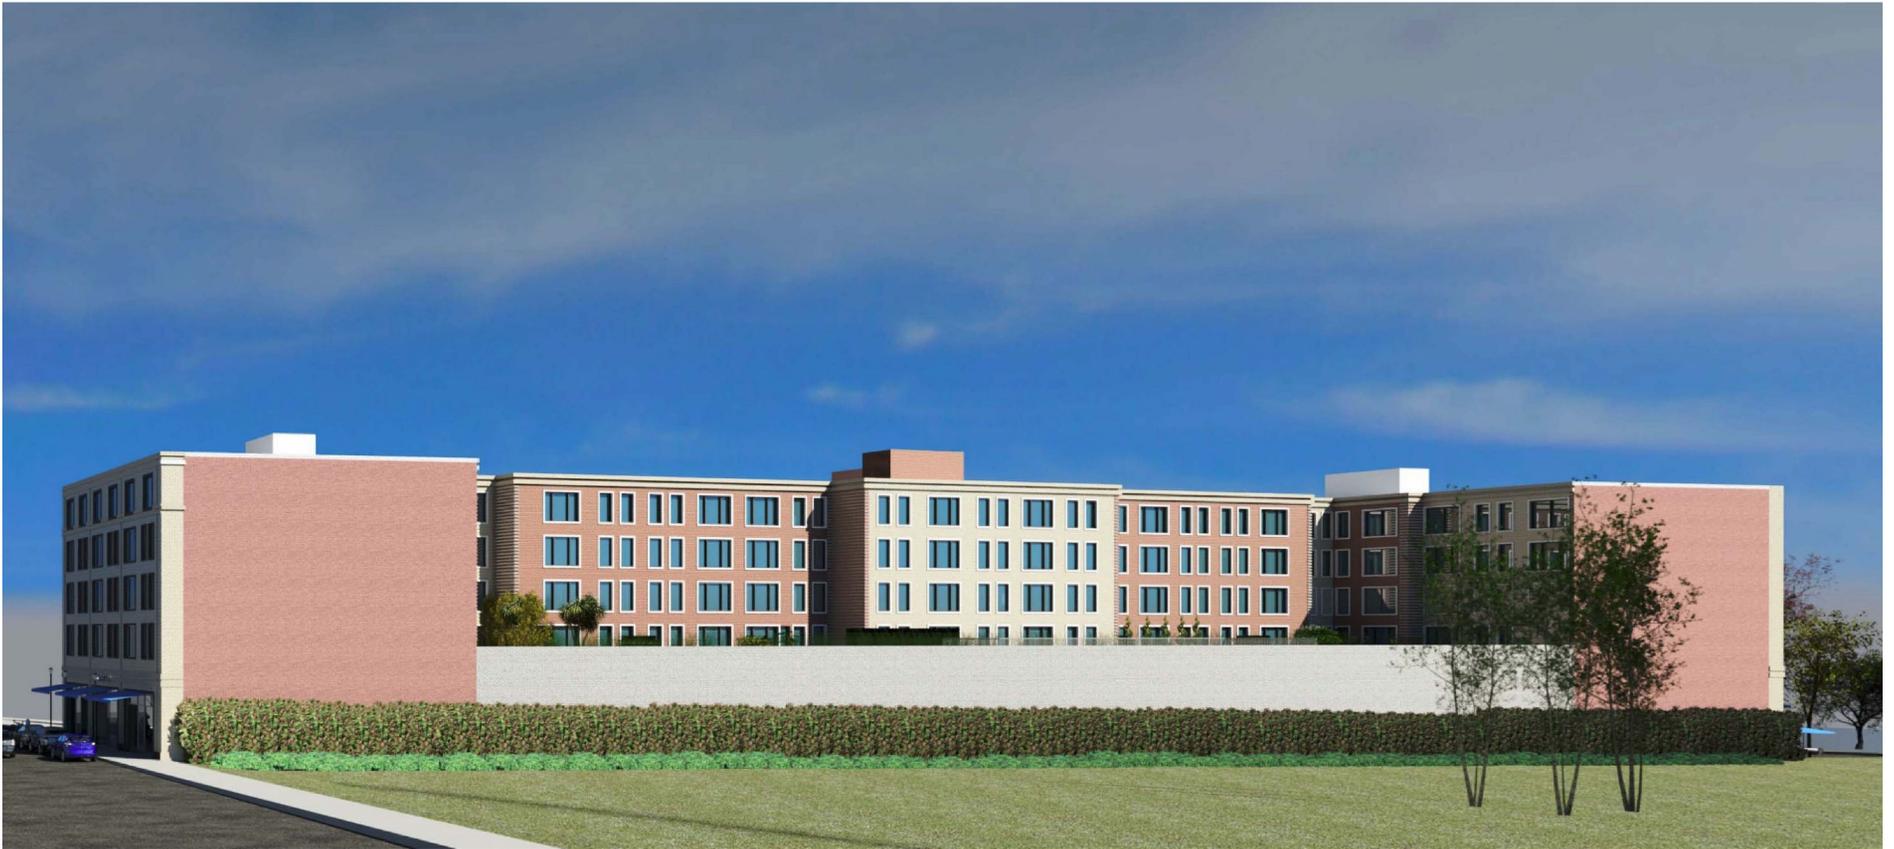
**6. Simulated view of western side of proposed mixed-use structure, toward southeast, from East Main Street.
Note: proposed building at 203-213 East Main Street not shown.**

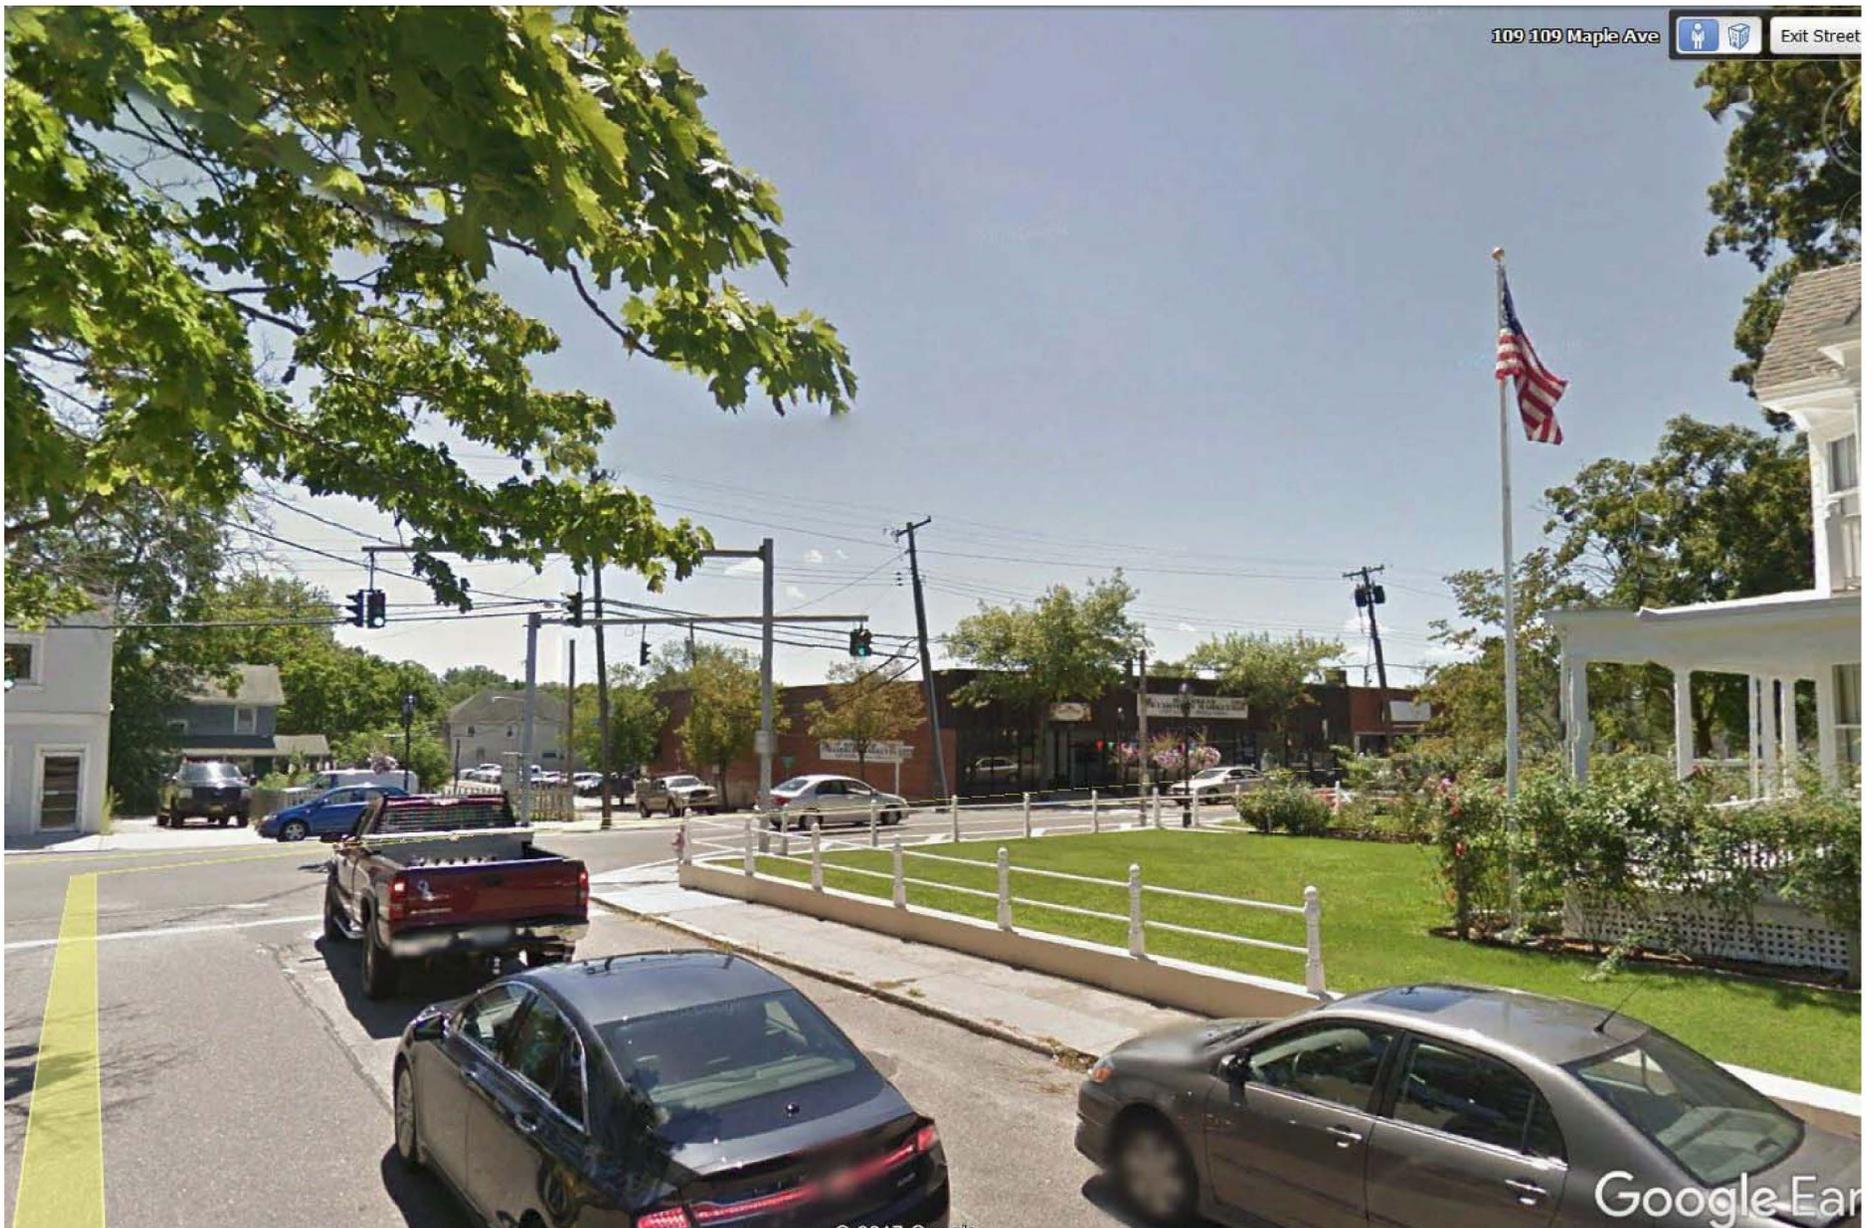
1. Existing view of northeastern corner of project site, toward southwest across intersection of McDermott Ave and East Main St.

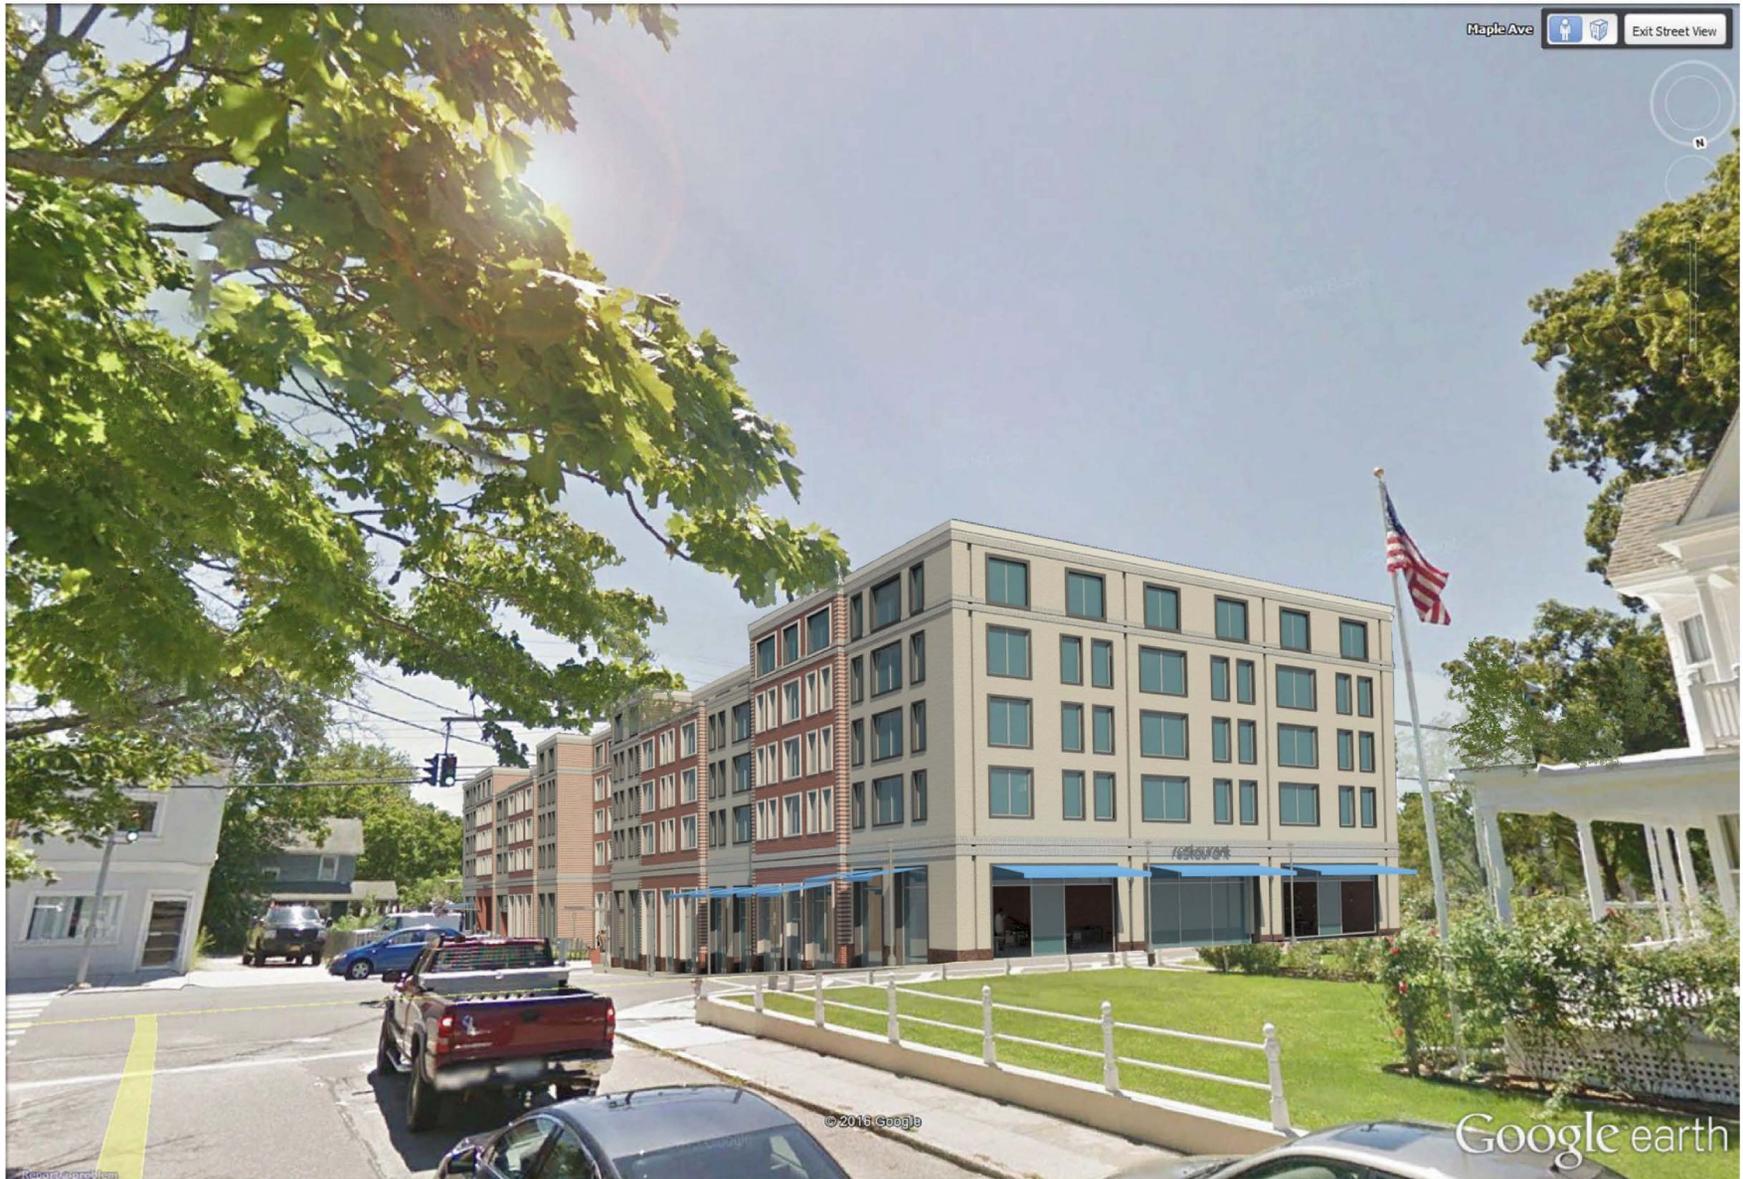
2. Simulated view of northeastern corner of project site, toward southwest across intersection of McDermott Ave and East Main Street.
